Hazardous Materials Survey Report

**Former Norwich State Hospital
Ribicoff Building
Circle B South
Preston, Connecticut**

**M&A Project No. 7055001.000
October 28, 2010**

**Mabbett & Associates, Inc.
Environmental Consultants & Engineers**

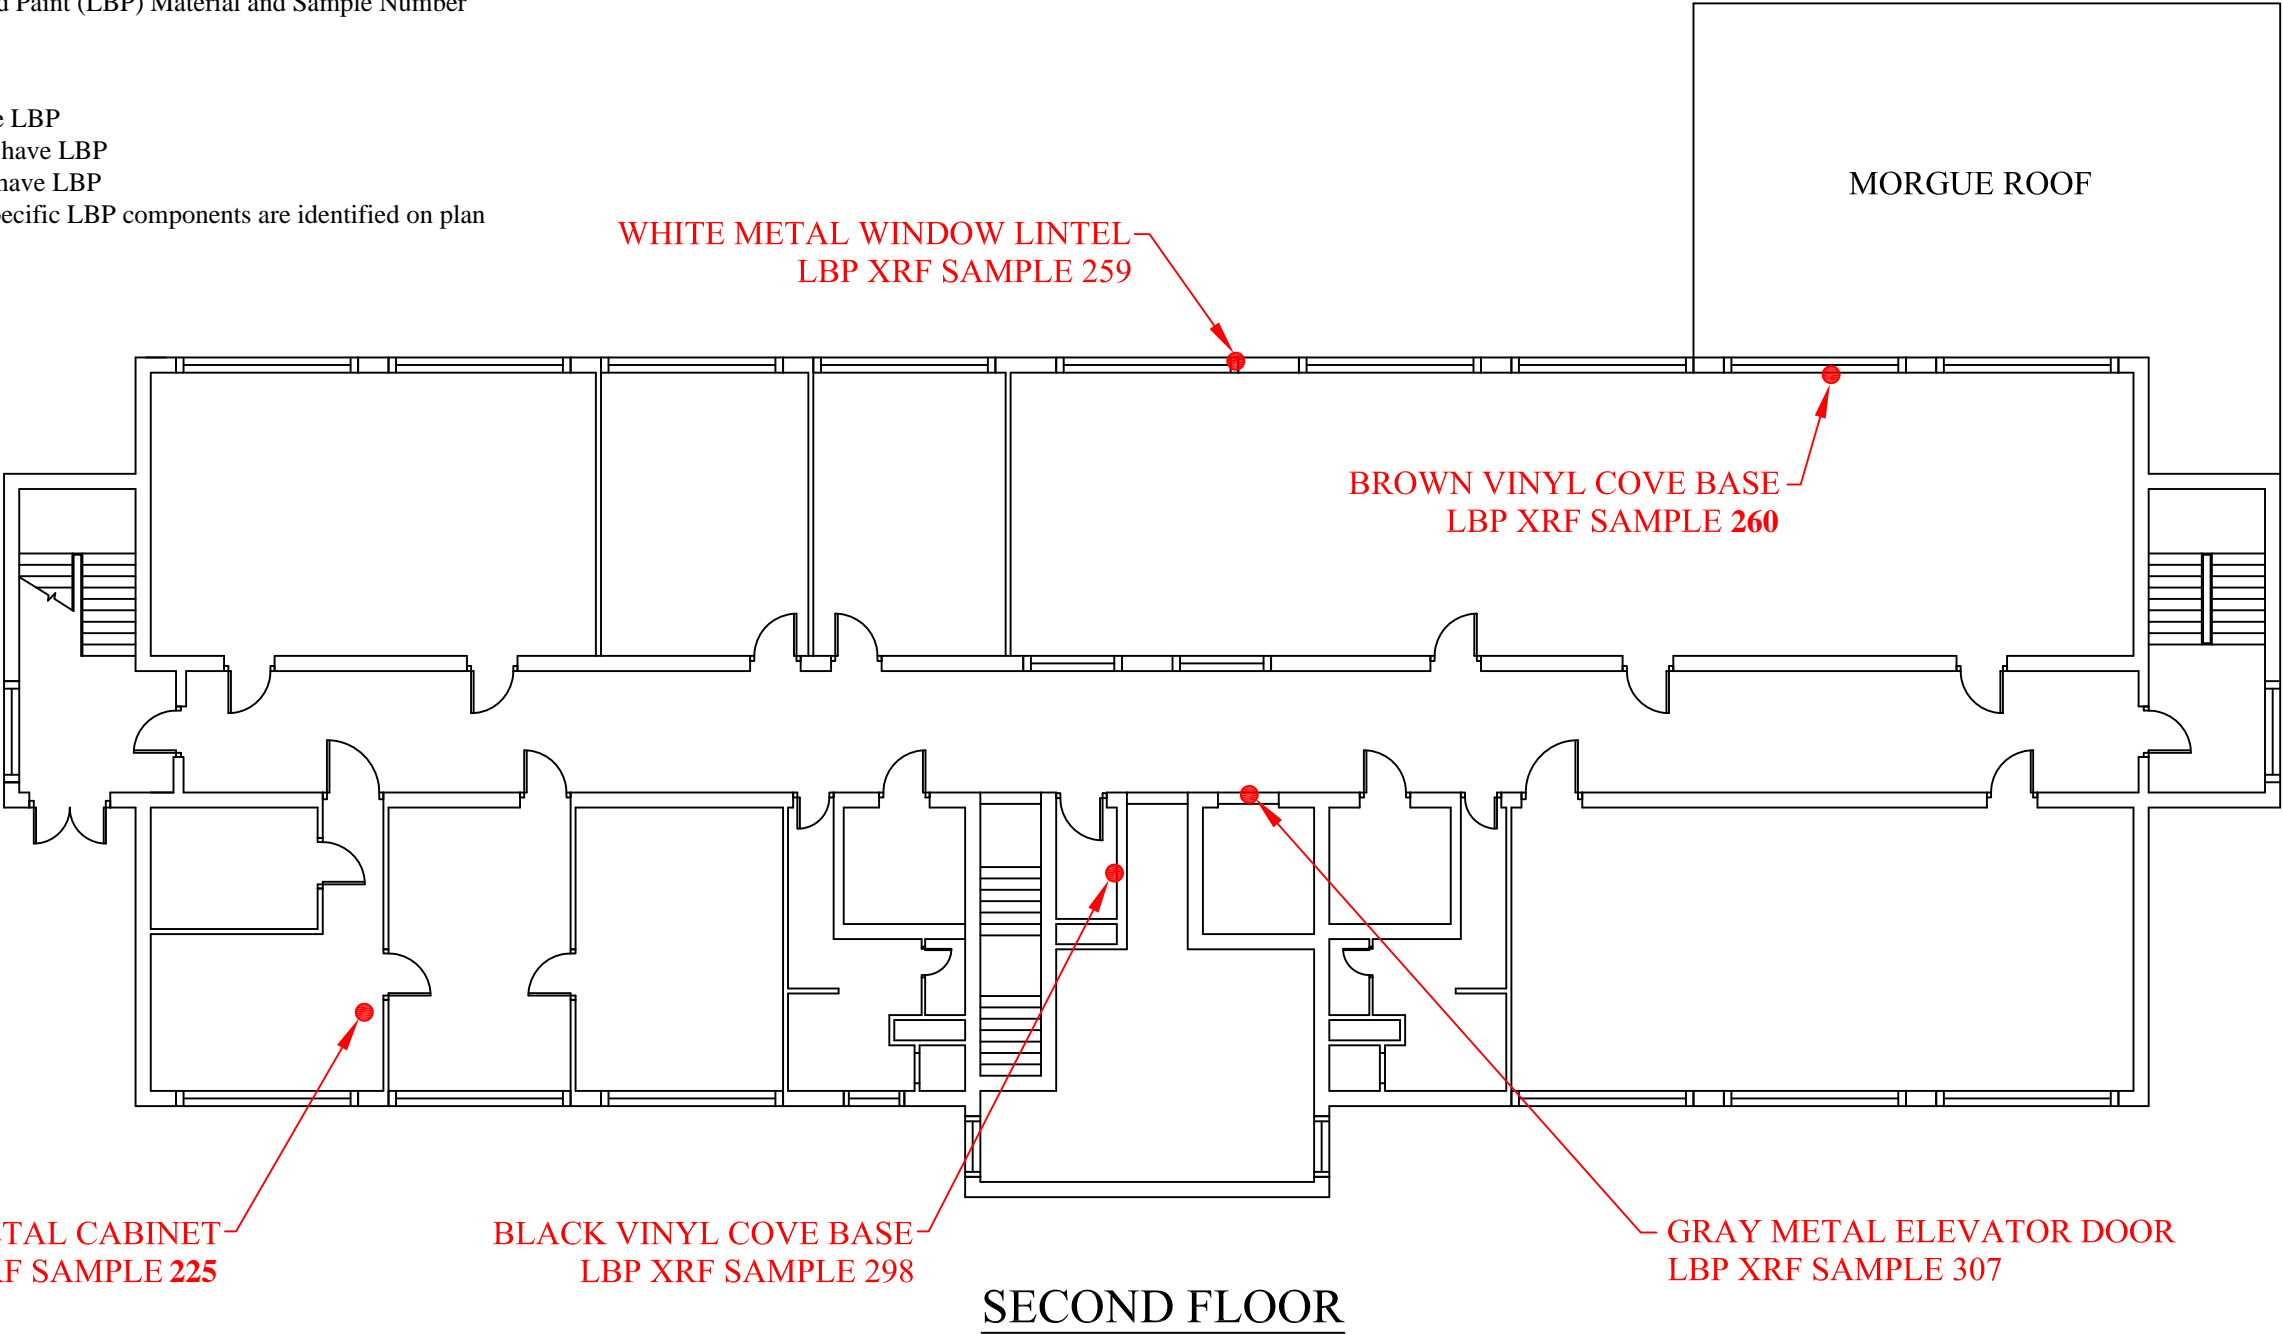
LBP notes:
All stair risers have LBP
All window lintels have LBP
All elevator doors have LBP
Additional floor-specific LBP components are identified on plan

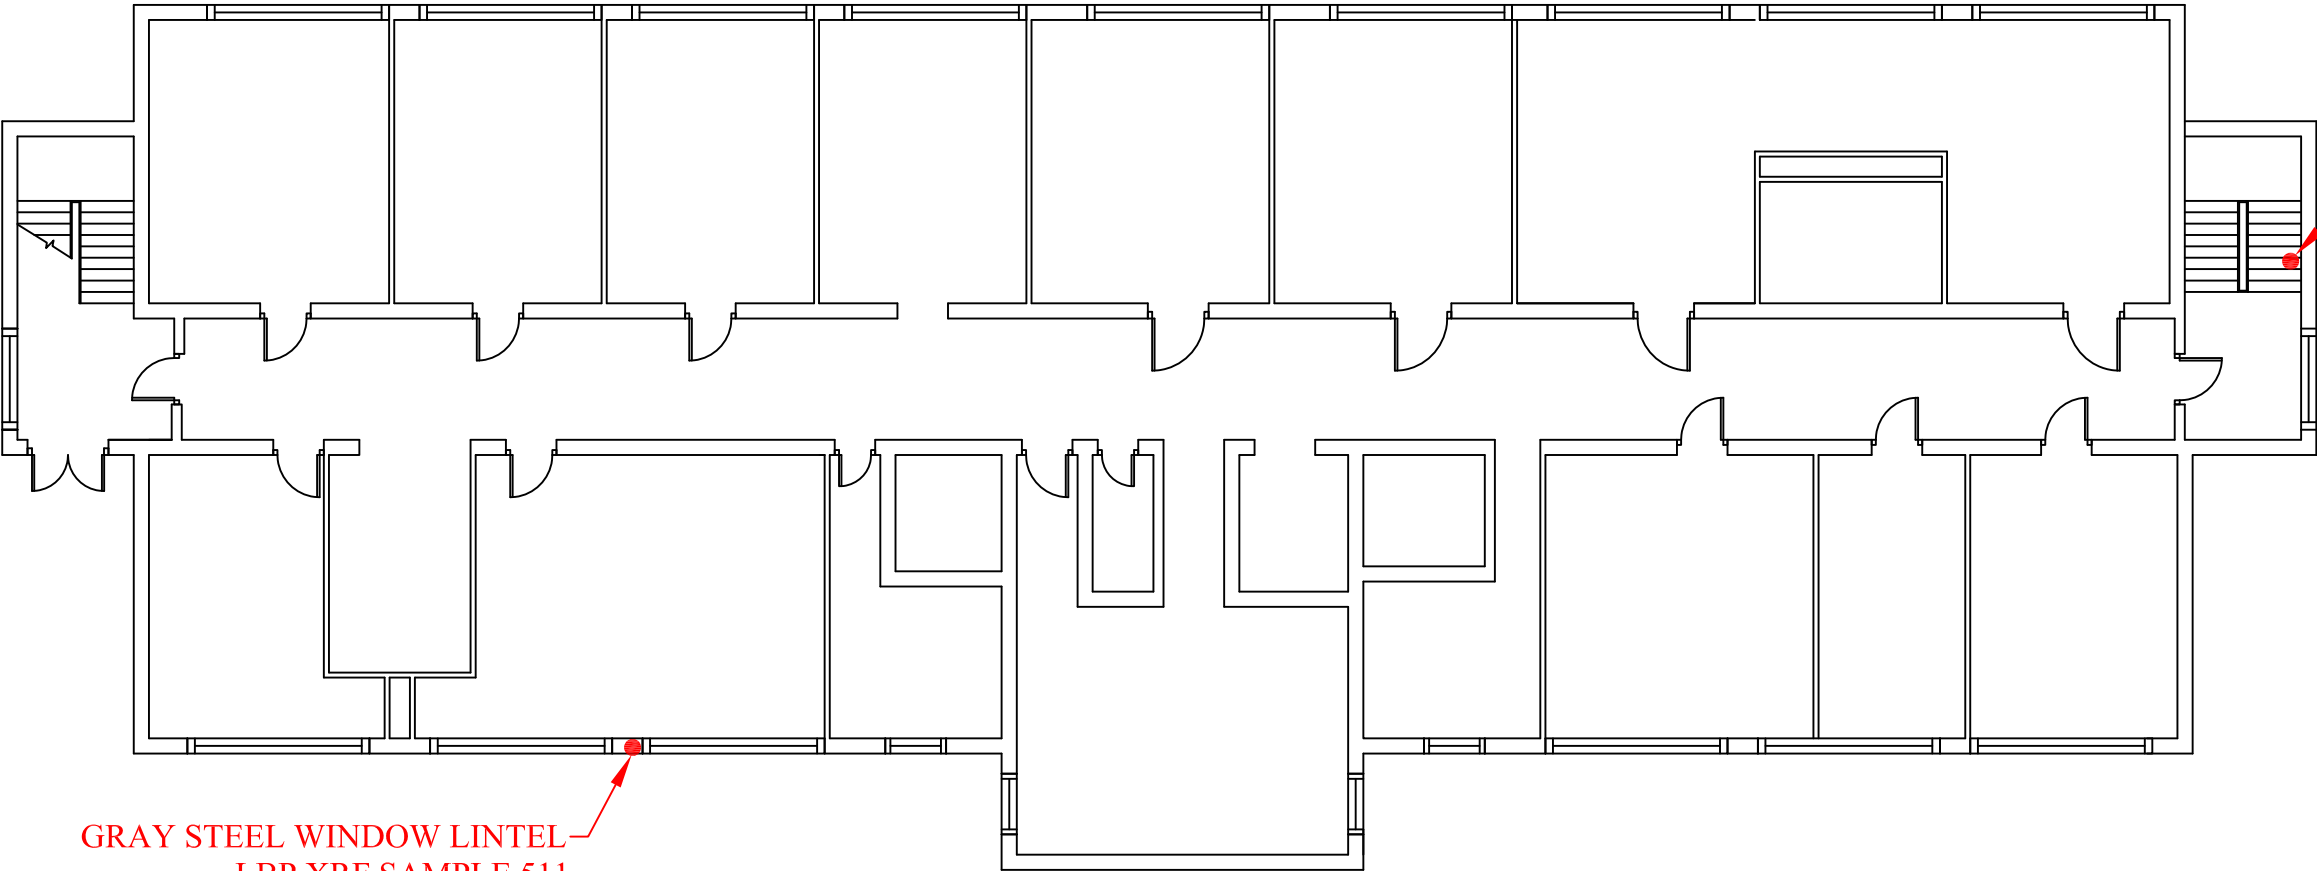
LBP notes:
All stair risers have LBP
All window lintels have LBP
Elevator doors have LBP
Additional floor-specific LBP components are identified on plan
